CONTRACT Window Replacements at:-
Willets Farmhouse
Alderwasley
Belper
DE56 2RA

TITLE
Window Details

DRAWING NUMBER
3613-03

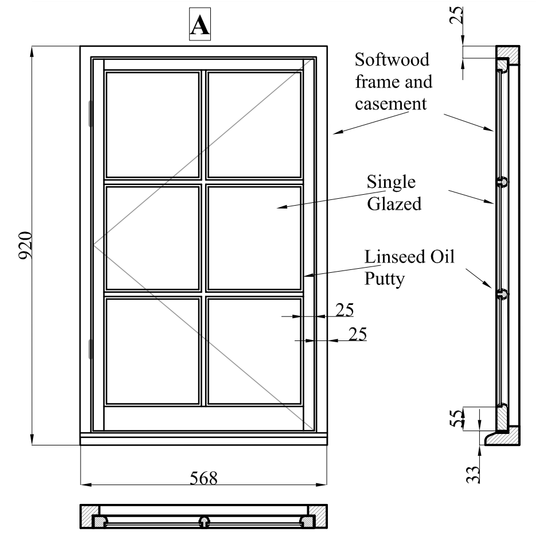
Existing Window.
Probably as installed at time of Grade 2 listing

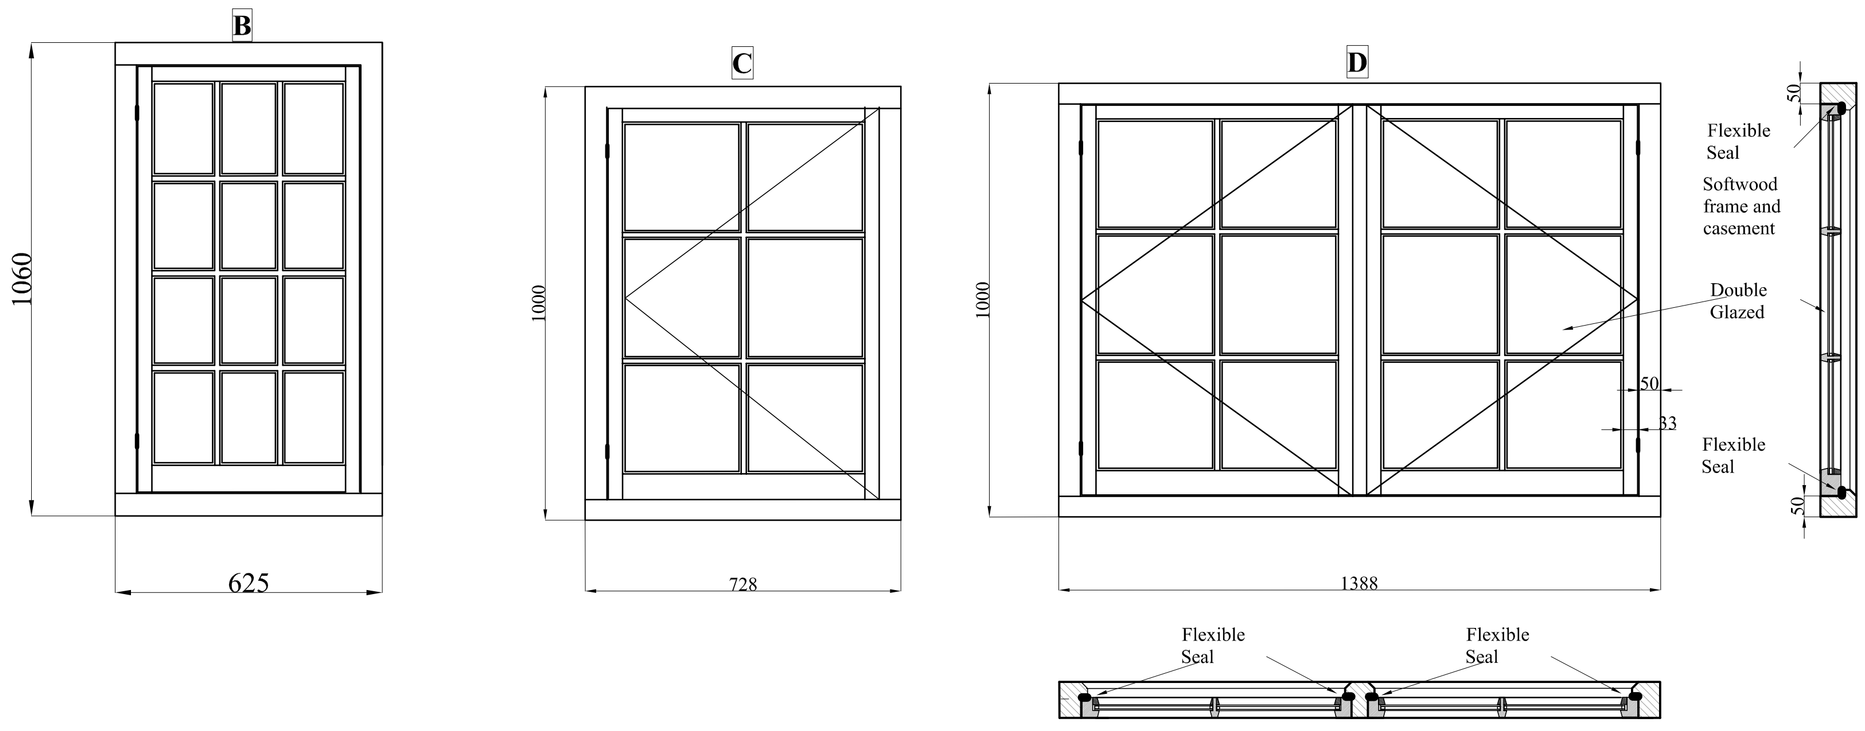
This window has severe rot in a large area and requires complete replacement
