REF: COR/2020/0080 - LISTED BUILDING CONSENT APPLICATION, APRIL 2021 - DOCUMENT D
8 TAMWORTH STREET, DUFFIELD, DE56 4ER (Grade 2 Listing: 1158259)
Disrepair and incorrect installation of 'Tulip' design panels.

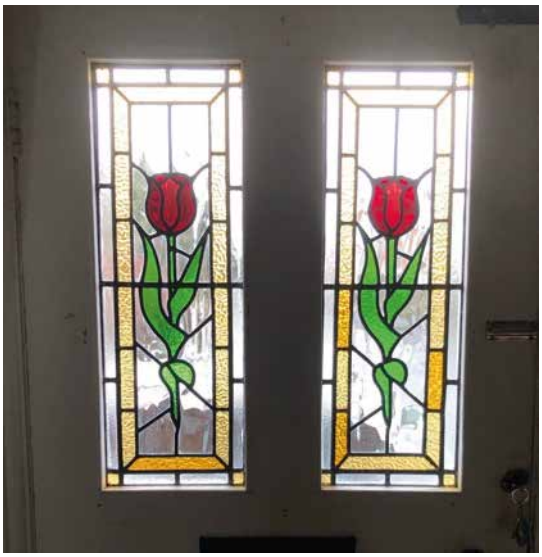
DANGEROUS CONDITION (BELOW 3 PHOTOS AND RIGHT): evidence of pronounced outward bowing and crack across the lower green glass portion.

POOR QUALITY (ABOVE): detail of poor quality leading and construction. Note central cross piece not considered in the design. 'Off the shelf' art nouveau style tulip motif holds no local or historical period relevance.

POOR INSTALLATION (RIGHT): existing tulip motif panels; incorrectly installed as non-mirroring design, and note difference in height of flowerheads.
