26 Shaw Lane, Milford DE56 0RE - Damaged Wall from a car accident (replacement)

05 - EXISTING ELEVATION 2

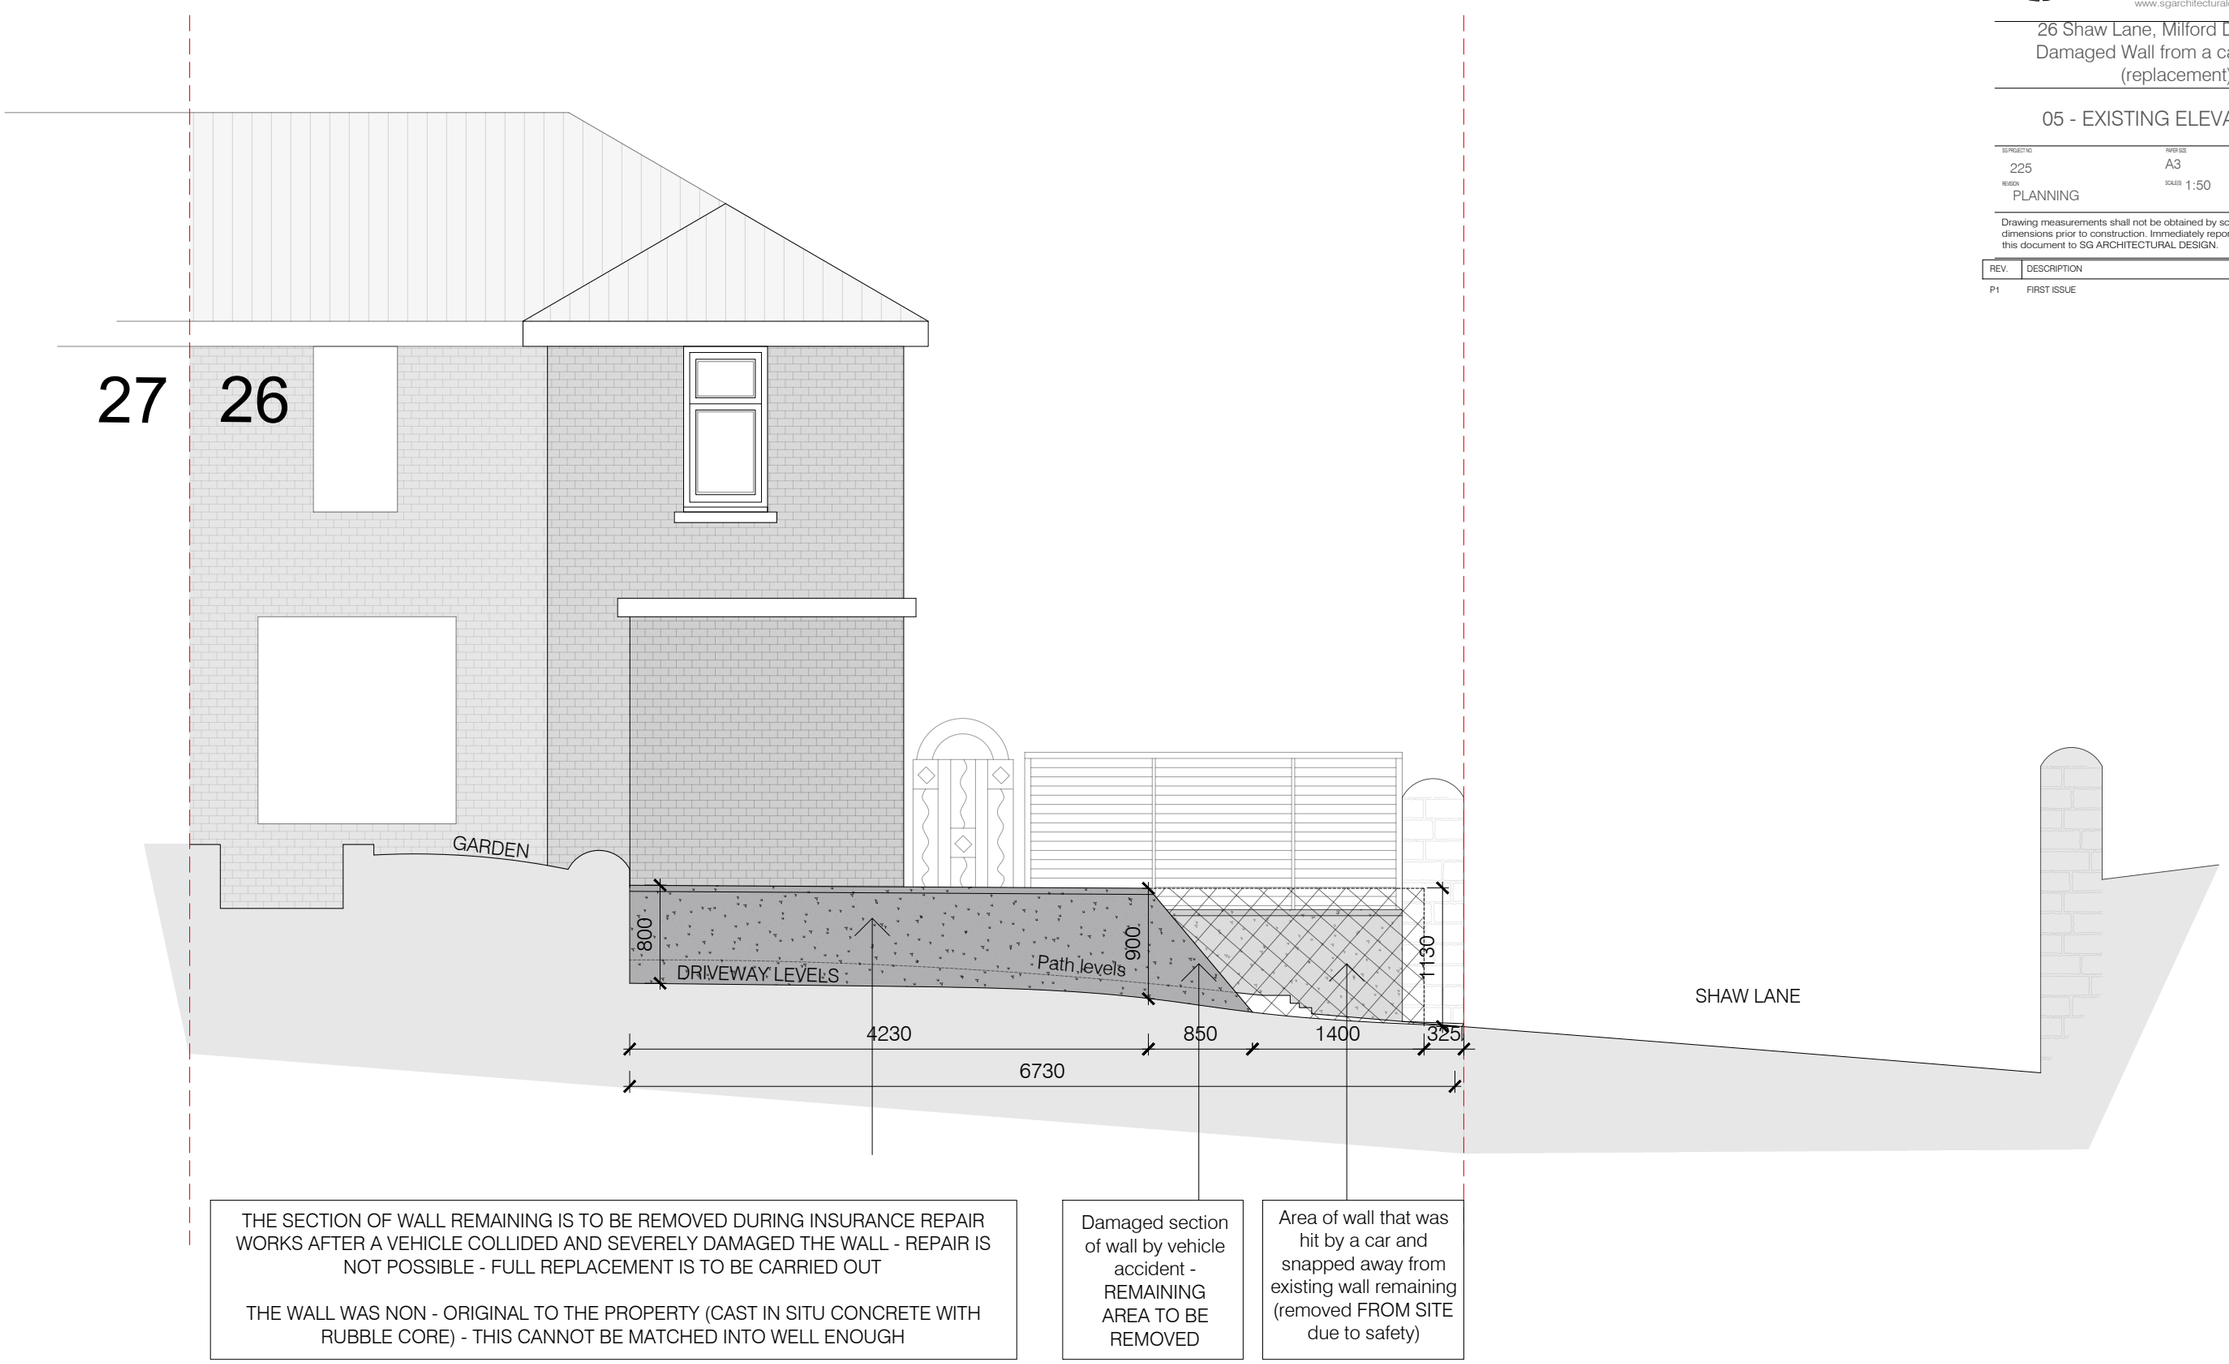
Elevation 2.

THE SECTION OF WALL REMAINING IS TO BE REMOVED DURING INSURANCE REPAIR WORKS AFTER A VEHICLE COLLIDED AND SEVERELY DAMAGED THE WALL - REPAIR IS NOT POSSIBLE - FULL REPLACEMENT IS TO BE CARRIED OUT

THE WALL WAS NON - ORIGINAL TO THE PROPERTY (CAST IN SITU CONCRETE WITH RUBBLE CORE) - THIS CANNOT BE MATCHED INTO WELL ENOUGH

Damaged section of wall by vehicle accident - REMAINING AREA TO BE REMOVED

Area of wall that was hit by a car and snapped away from existing wall remaining (removed FROM SITE due to safety)
