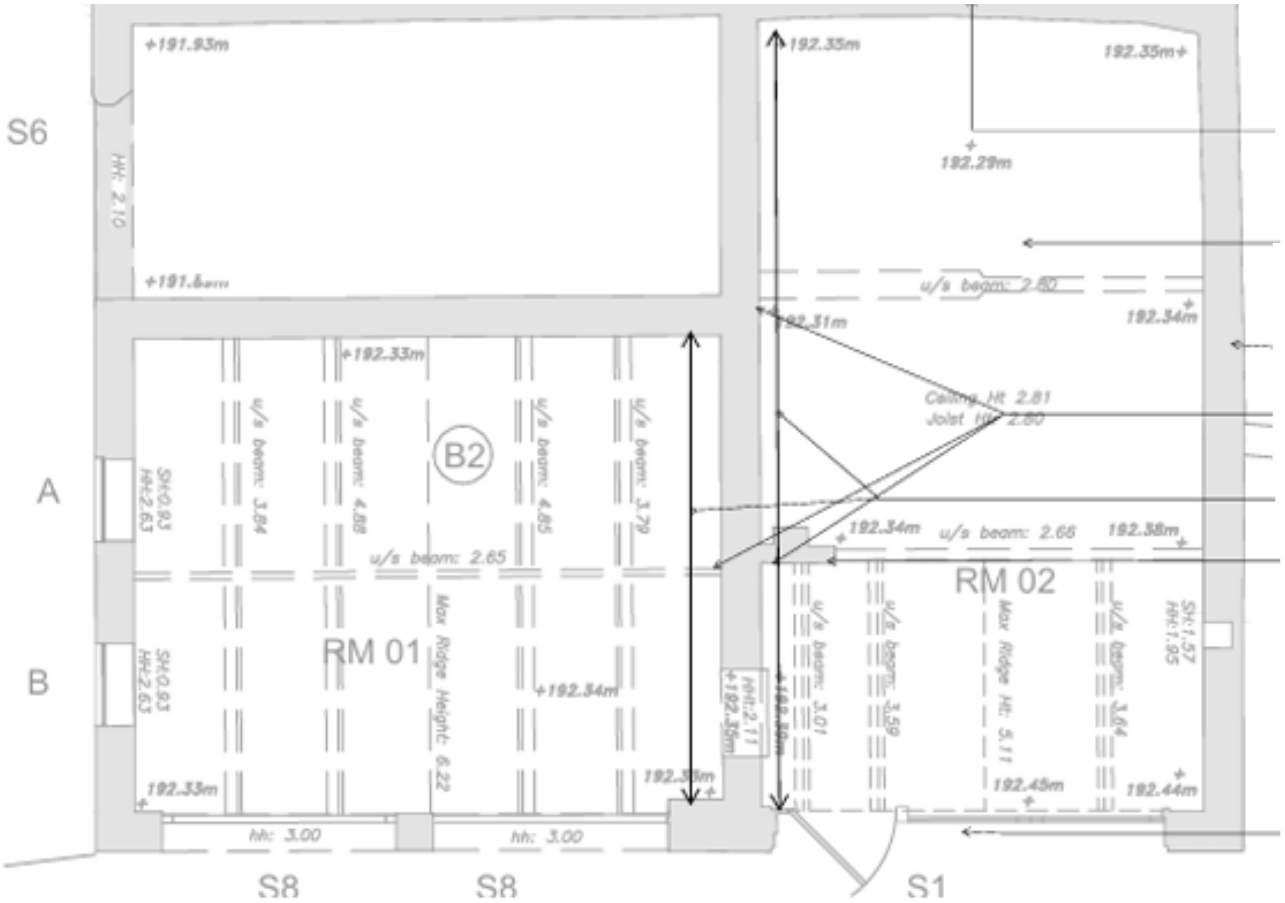
Existing rubble filled gable wall is significantly out of plumb – to be rebuilt like for like using site won stone with NHL2 mortar

Roof to be rebuilt

Existing rubble filled wall to be rebuilt as elevation. New 100hx200w hardwood wall plate to be installed and tied to trusses

Trusses to be realigned and repaired with shoe repair

Valley rafters to be repaired

Pier to be removed

Existing cavity gable wall to be dismantled and rebuilt on new 2No. 152x152x30 UCs bolted together at 600 centres with flashing and timber cover plate by others. Existing stone façade to be reused. Backing brick is not original and can be replaced.
